QUALITATIVE EROSION AND SEDIMENTATION INVESTIGATION MALINE CREEK

QUALITATIVE EROSION AND SEDIMENTATION INVESTIGATION MALINE CREEK CITY AND COUNTY OF ST. LOUIS, MISSOURI

Simons, Li & Associates, Inc. 3555 Stanford Road P.O. Box 1816 Fort Collins, CO 80522

July 30, 1985

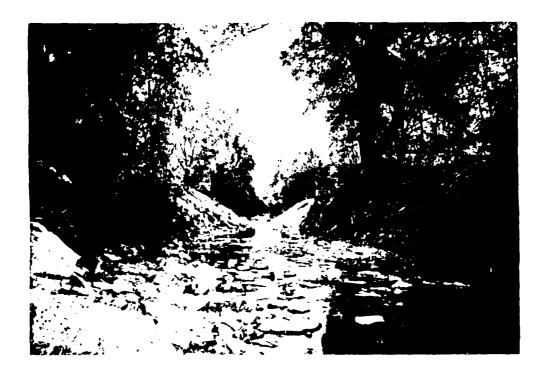
Figure 3.4a. Rubble used for bank protection has fallen into the channel and covers the bed of many parts of Maline Creek.

(Photograph looking downstream from Florissant Road)

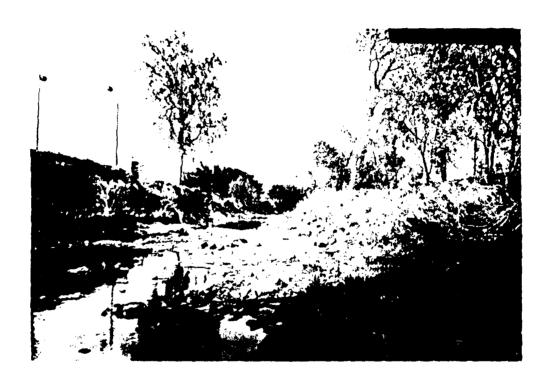
Figure 3.4b. Rubble used for bank protection has fallen into the channel and covers the bed of many parts of Maline Creek.

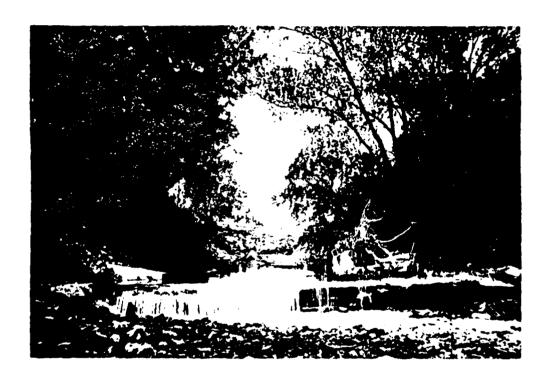
Figure 3.6a. Exposed sewer line encasement.

were exposed. In most cases, the water plunged two to three feet on the downstream side of the these structures. At several of the locations rubble or stone had been dumped on the downstream side to protect against scour.

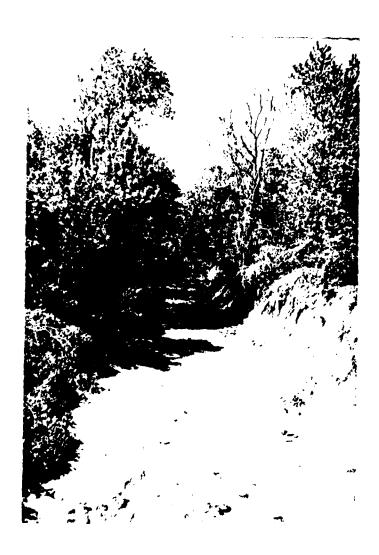
Bank erosion is occurring at numerous locations. The erosion appeared to be as much the result of geotechnical conditions in the loess as hydraulic conditions. Typically, bank erosion was occurring as a result of slope failure. It appeared that saturation of the soils in the late winter and early spring had induced some of the failures. The material was deposited at the toe of the slope, often with the vegetation still partially intact (Figure 3.8). During significant flows, the material will be removed from the toe and carried downstream. This is a common erosion cycle for loess streambanks.

Figure 3.7. Typical banks along Maline and Blackjack Creeks. Upper 10-15 feet is loess. Below this is found a loess material with a much higher clay content.

(Photograph looking upstream along Maline Creek approximately imile upstream of Florissant Road)

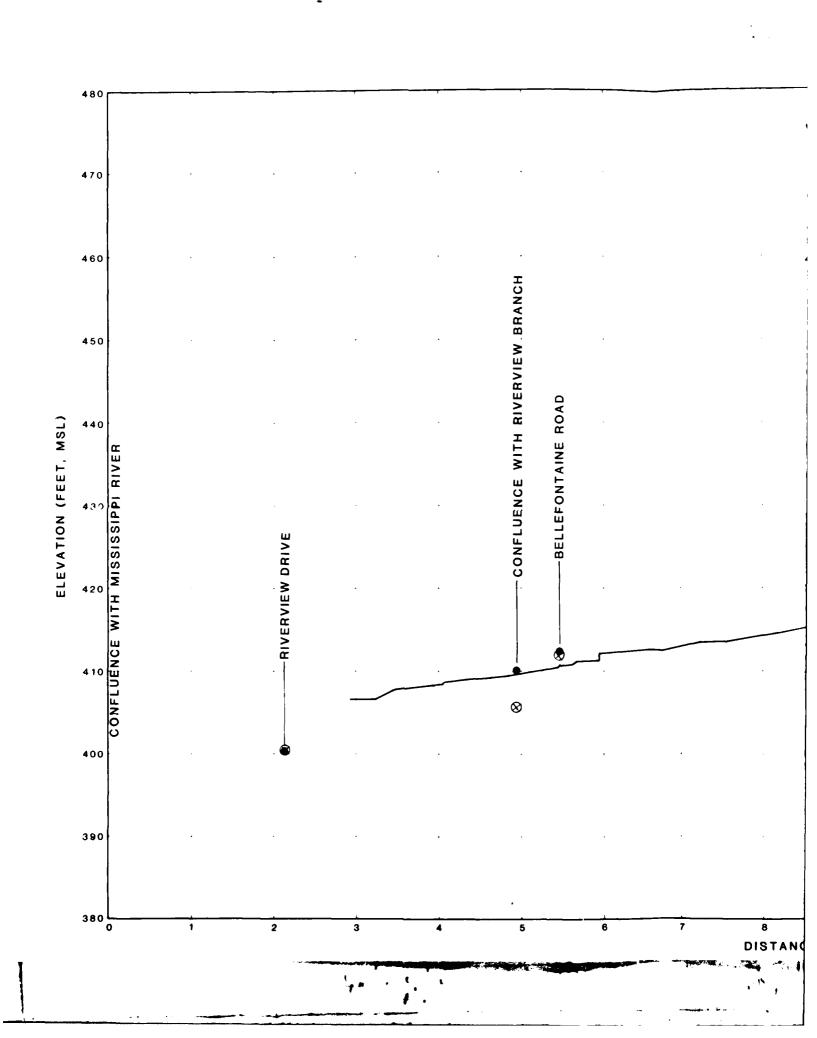
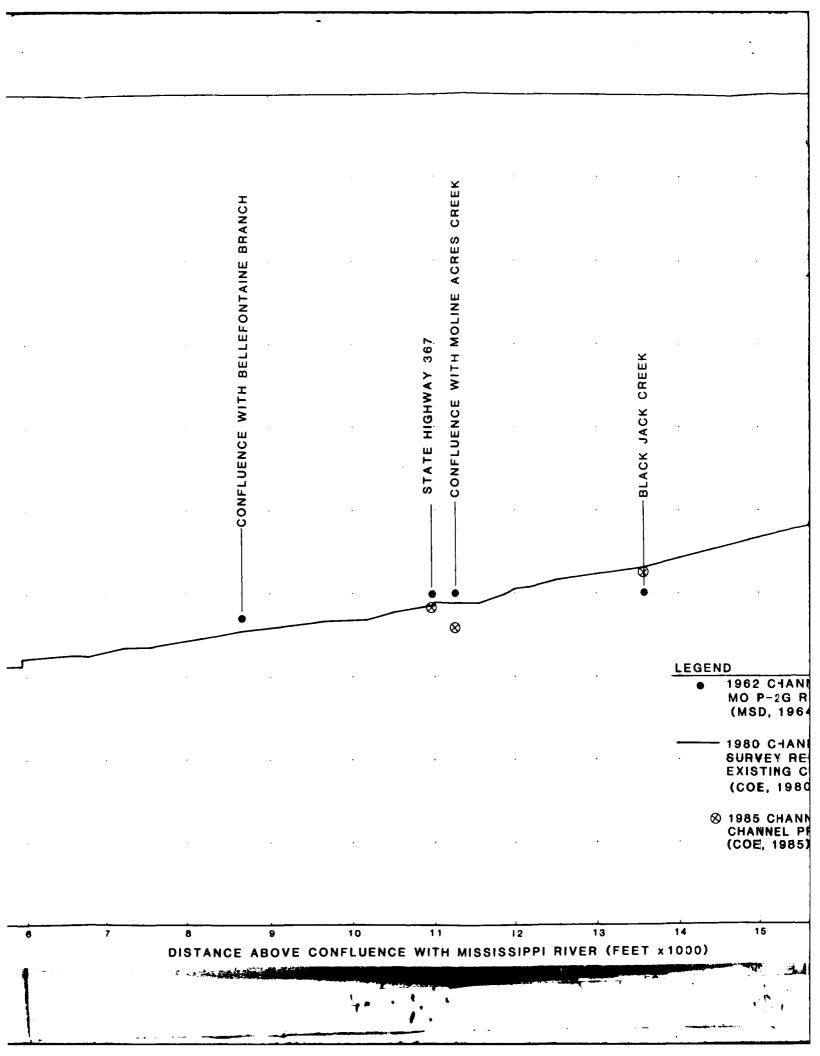
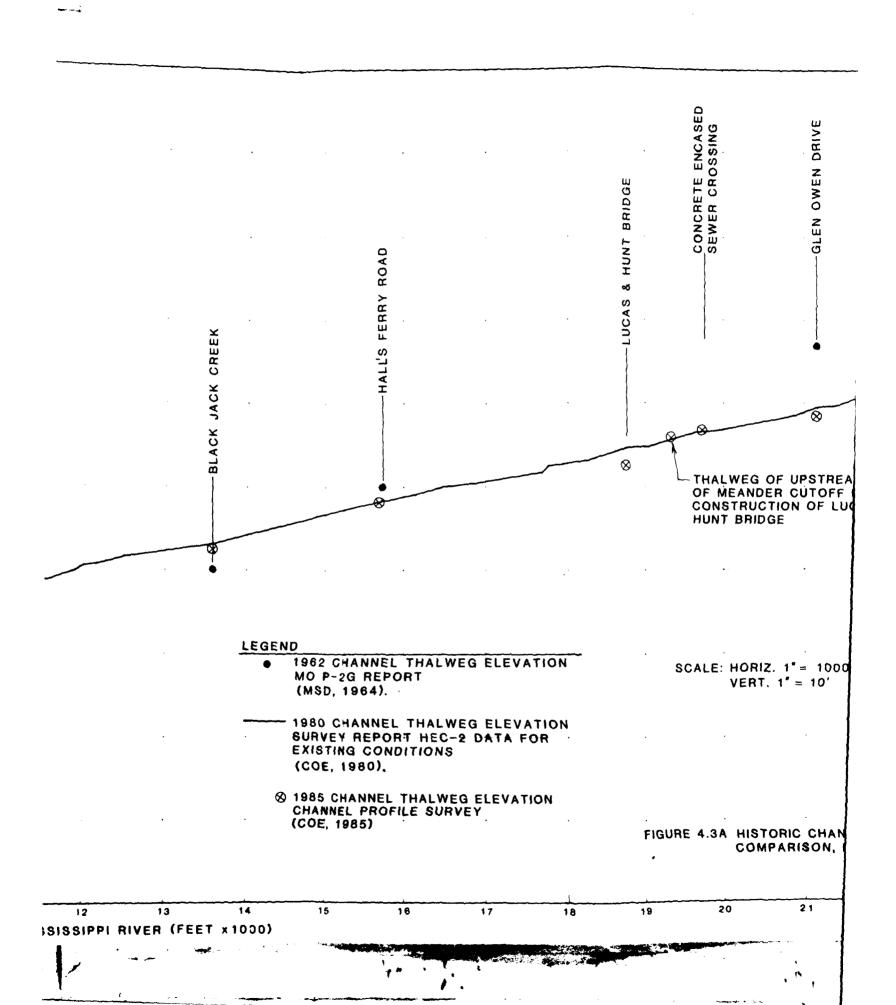
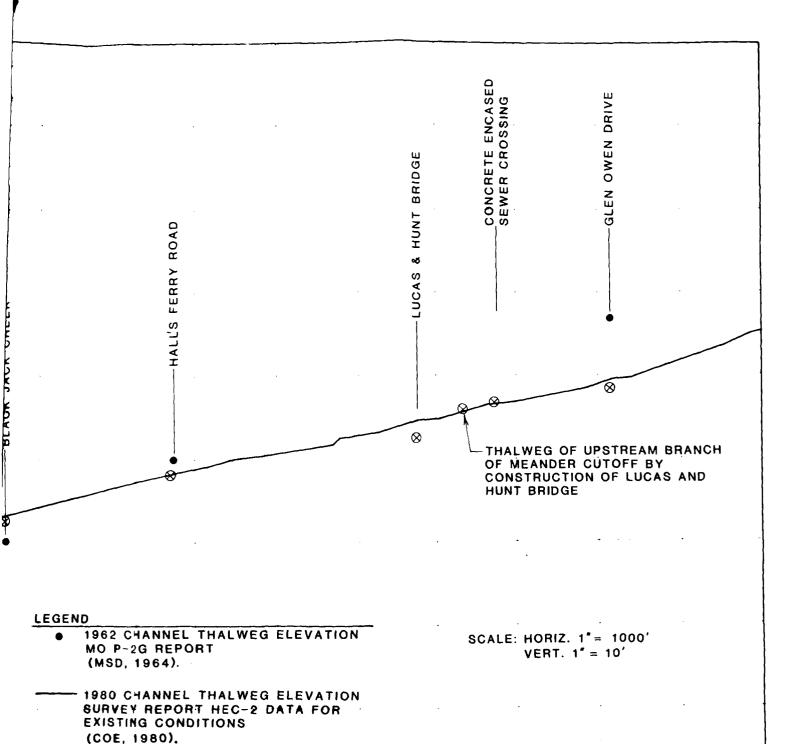
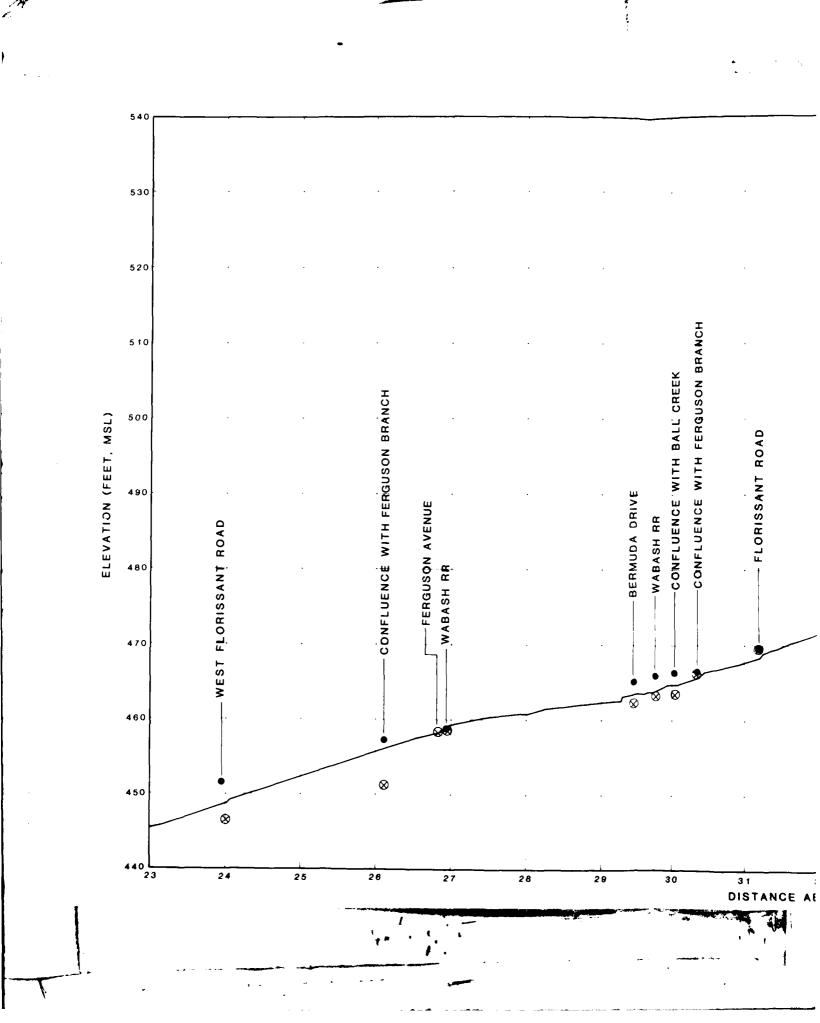
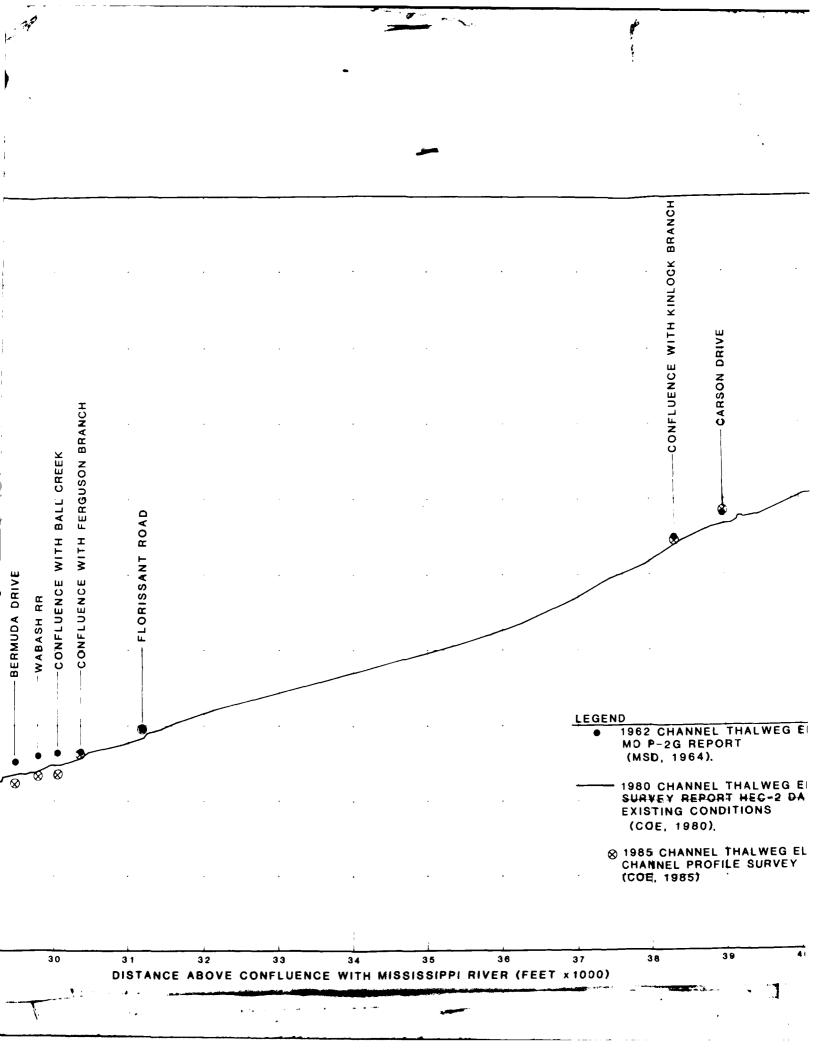
FIGURE 4.3A HISTORIC CHANNEL PROFILE COMPARISON, MALINE CREEK

As can be seen in Figure 4.3a, the general trend of Maline Creek is an overall degradation of the channel profile. The channel bed has eroded between one to three feet over most of its length. The overall erosion of the channel profile indicates a deficit of available sediment compared to the transport capacity of the stream. The large amount of urban area in the watershed has reduced available sediment and increased the runoff and consequent sediment transport capacity of the stream.

At the confluence of Blackjack Creek, the channel was found not to be following the overall trend of channel degradation. The channel invert has aggraded approximately four feet in this area. This is believed to be a localized condition. The amount of sediment supplied by bank erosion occurring along Blackjack Creek is apparently greater than the sediment transport capacity of Maline Creek at their confluence, thus causing the observed change in bed elevation.

At Glen Owen Drive the channel bed has degraded approximately twice as much as was generally observed throughout the profile. The 1980 channel was seen to be approximately seven feet lower than that observed in 1963. This change is due to the cutoff downstream of a meander bend made during construction of the Lucas and Hunt Road extension. The length of the channel in this reach changed from a natural length of 3,600 feet to a channelized length of 1,800 feet. The shortening of the channel has steepened the slope causing higher channel velocities and increased erosion of the channel.

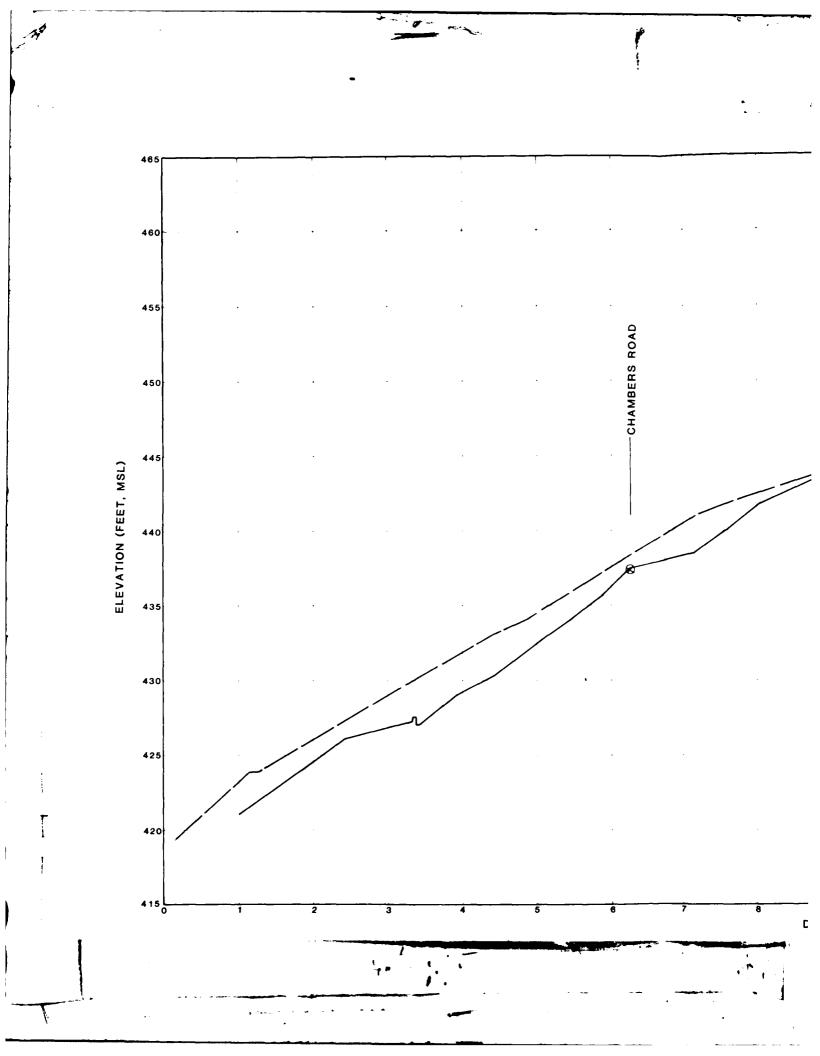
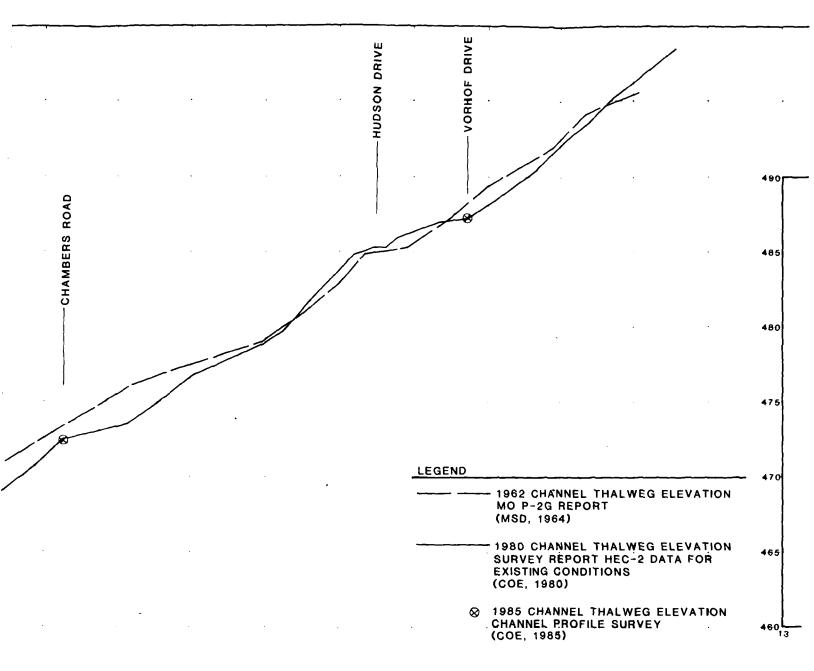
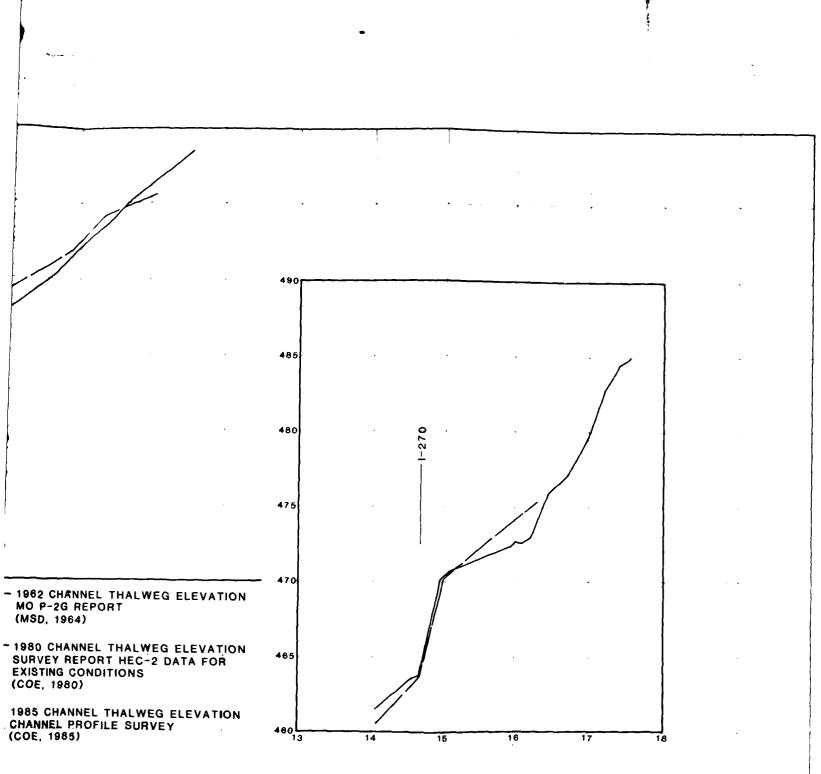
FIGURE 4.3B HISTORIC CHANNEL PROFILE COMPARISON BLACKJACK CREEK

As can be seen in Figure 4.3b, the general trend of Blackjack Creek is an overall degradation of the channel profile. Similar to Maline Creek, the channel bed has eroded between one to three feet over most of this length. The overall erosion of the channel profile indicates a deficit of available sediment compared to the transport capacity of the stream.

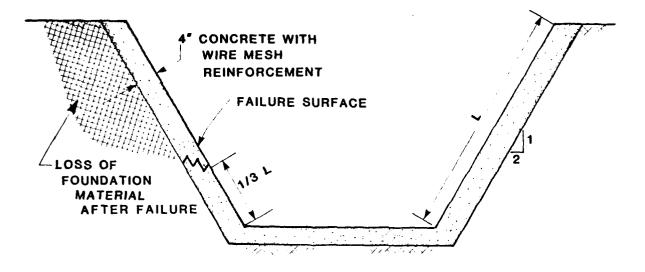
From discussions with the Metropolitan St. Louis Sewer District (MSD) it was learned that in the past they had experienced problems with 2 horizontal to 1 vertical sideslope trapezoidal concrete-lined channels. A common condition was described where the sideslope failed approximately one-third of the distance up the sideslope allowing foundation material to wash out. Figure 4.8 is definition sketch of the problem. MSD said that failures occurred even though adequate weep holes and filters were utilized. They also said that modification of the standard design used for concrete trapezoidal channels seemed to have prevented this problem from occurring. The modification changed using a 4-inch thick wire mesh reinforced sidewall to a 7-inch thick steel reinforced sidewall.

Figure 4.8. Typical failure of concrete trapezoidal channel as described by Metropolitan St. Louis Sewer District.

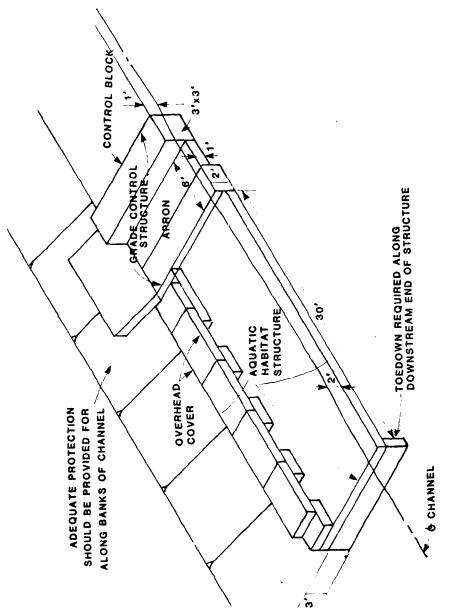
Figure 4.11. COMBINATION AQUATIC HABITAT
AND GRADE CONTROL STRUCTURE

A review was made of the proposed design for the aquatic habitat structures to determine its potential effect on sediment transport. As seen in Figure 4.11 no bank protection is utilized on the sideslopes of the channel. It is recommended that proper bank protection be provided since the banks are composed of fine loess material, which is highly erodible. Without proper bank protection it is possible that the stream could bypass the structure.

Another recommendation for their design is to toedown the structure at least 3 feet on the downstream side. The purpose of the toedown is to prevent headcutting of the channel underneath the structure.
